# Manhole Inspection Summary

Manhole # S35A\_\_002MH

Insp Date: **11/14/07 8:39 AM**

**Location** Address: **opp.649 st paul st**

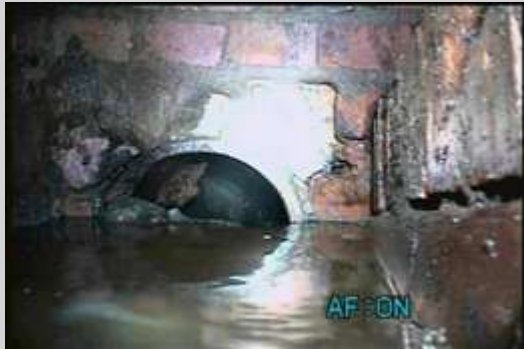
12 O'Clock Outflow

12 in. Circular Gravity Sewer  
Pipe Out @ 12 O'Clock

Pipe Material: **Clay** ☐ Pipe Lined

Invert Depth: 11.00 (ft.) Flow Characteristics: **Slow**

Deposits: ☒ None ☐ Mud ☐ Sludge ☐ Debris ☐ Grease

Infiltration: **None** Pipe Seal Cond: **Unknown**

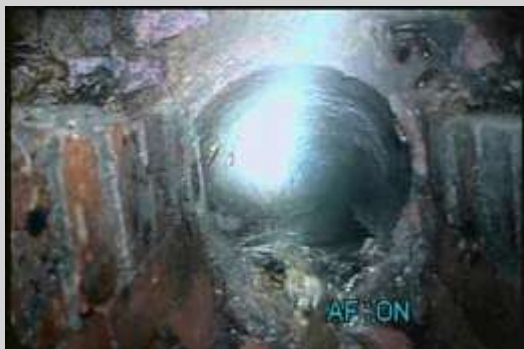
6 O'Clock Inflow

8 in. Circular Gravity Sewer  
Pipe In @ 6 O'Clock

Pipe Material: **Clay** ☐ Pipe Lined

Invert Depth: 10.90 (ft.) Flow Characteristics: **Slow**

Deposits: ☒ None ☐ Mud ☐ Sludge ☐ Debris ☐ Grease

Infiltration: **None** Pipe Seal Cond: **Unknown**

Connects To: **Stub connection / abandoned**

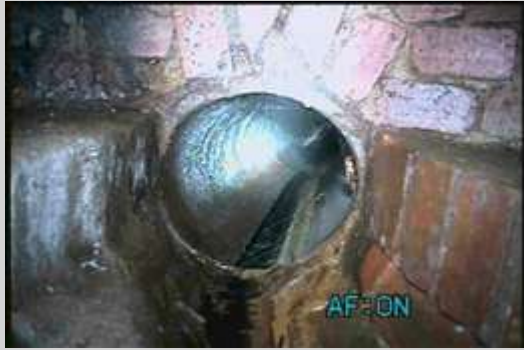
9 O'Clock Inflow

8 in. Circular Gravity Sewer

Pipe In @ 9 O'Clock

Pipe Material: **Clay** ☐ Pipe Lined

Infiltration: **None** Pipe Seal Cond: **Unknown**
